Massachusetts Department of Environmental Protection Bureau of Resource Protection – Watershed Permitting Program Sanitary Sewer Overflow (SSO)/Bypass Notification Form

061218 - Pump Station A

Town of Hull Wastewater Treatment Plant

Unauthorized Discharge Summary Pump Station [LS A] [6-12-18]

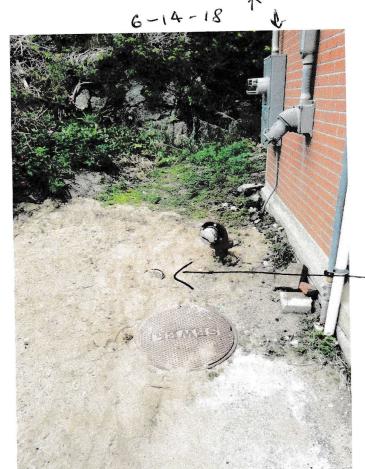
REPAIRED DER VALVE
AFTER REPAIRS G-13-18

Cause of the unauthorized discharge, (blockage or break; mechanical, electrical, or structural failures);	Failure of drain back valve
If caused by a blockage, identify the type of blockage (e.g., grease, rags, debris);	NA NA
If caused by a mechanical, electrical, or structural failure, the date of the last inspection, maintenance, or repair of the failed asset;	Component used approximately 3 months earlier on 3/13/18.
Did the release reach any portion of the Town's Municipal Separate Storm Sewer System ("MS4").	No release to MS4; no storm drains in this area.

If the release occurred to the ground, provide the location of the nearest down-gradient catch basin and the name of the receiving water to which the catch basin discharges;	No near-by down-gradient catch basins. Leak was adjacent to pump station.
Did the release reach a wetland or surface water?	No
If so, include the name and exact location where?	
Measures taken to minimize the volume and duration of the unauthorized discharge;	Noted above and on SSO form. Diverted/diked sewage back to the wet well manhole.
Measures taken to clean the area where the unauthorized discharge occurred;	Lime applied to all areas; repairs made the following day.
Corrective actions taken to prevent reoccurrence of unauthorized discharges at the same location;	New valve installed on 6/13/18
Date of the last unauthorized discharge in the same general location;	3/13/18
